Manhole Inspection Summary

Manhole # S29AA1030MH

Insp Date: **12/11/06 8:32 AM**

Location Address: **3551 KESWICK RD**

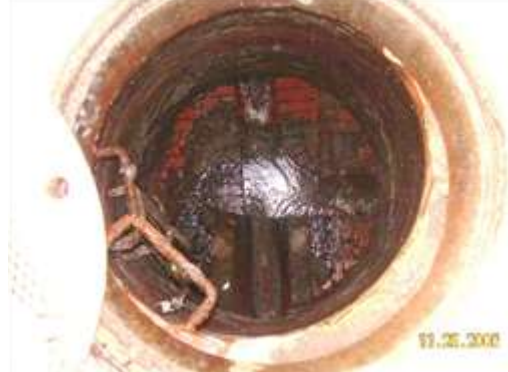
Top View

Corroded steps. Adjustment deterioration, loose brick and infiltration. Evidence of surcharge - Bench debris. Channel

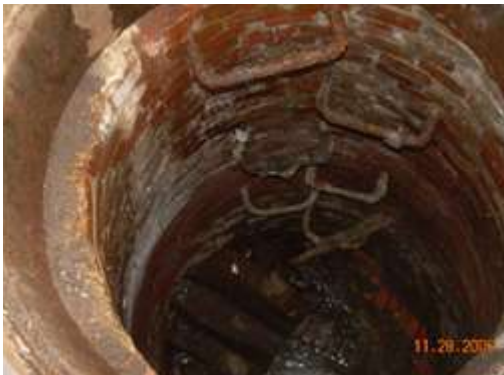
Defect

Frame leak. Frame offset. Adjustment, Corbel and Barrel infiltration. Evidence of surcharge - Bench debris.

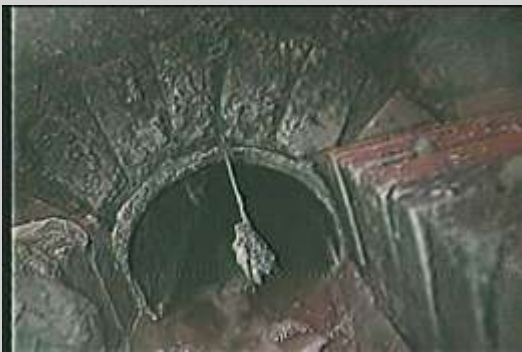
8 in. Circular Gravity Sewer Pipe Out @ 12 O'Clock

Deposits: ☐ None ☒ **Mud** ☐ Sludge ☒ **Debris** ☐ Grease

Silt Depth: **0.5** (in.) Deposits Extent: **Light**

Infiltration: **Evidence** Pipe Seal Cond: **Roots**

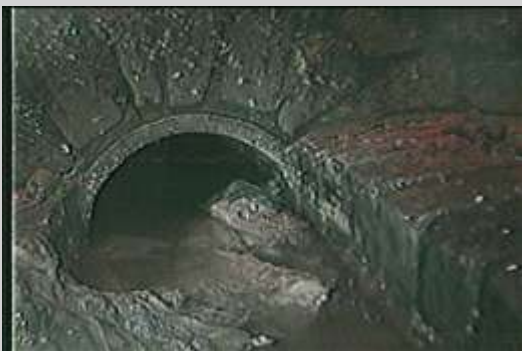
8 in. Circular Gravity Sewer Pipe In @ 3 O'Clock

Channel debris

Deposits: ☐ None ☐ Mud ☐ Sludge ☒ **Debris** ☐ Grease

Silt Depth: **0** (in.) Deposits Extent: **Medium**

Infiltration: **Evidence** Pipe Seal Cond: **Unknown**

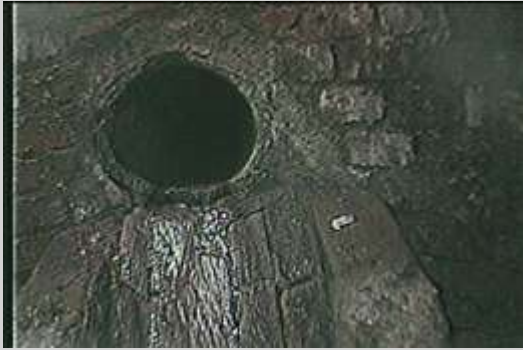
8 in. Circular Gravity Sewer

Infiltration: **Evidence**
